Video Conferencing Products Technical Bulletin 70-2005-002R

SUBJECT: UPnP SUPPORT

MODEL: PCS-1
PCS-11

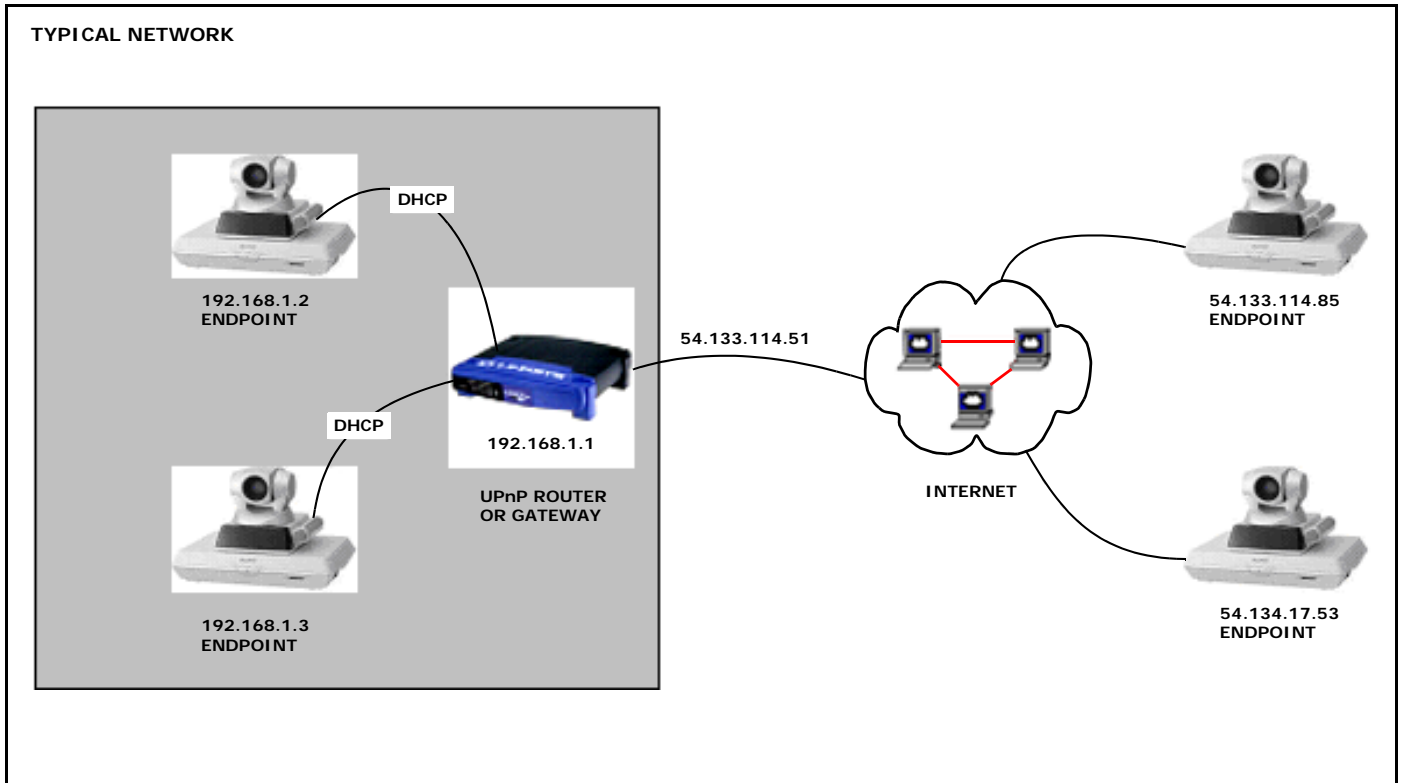
Figure 1 shows a typical network environment where PCS-1/11 is used with a UPnP-enabled gateway/router.
